# NH Dredge Task Force Meeting

Seabrook-Hampton Bridge Project  
Project No. 15904

February 6, 2019

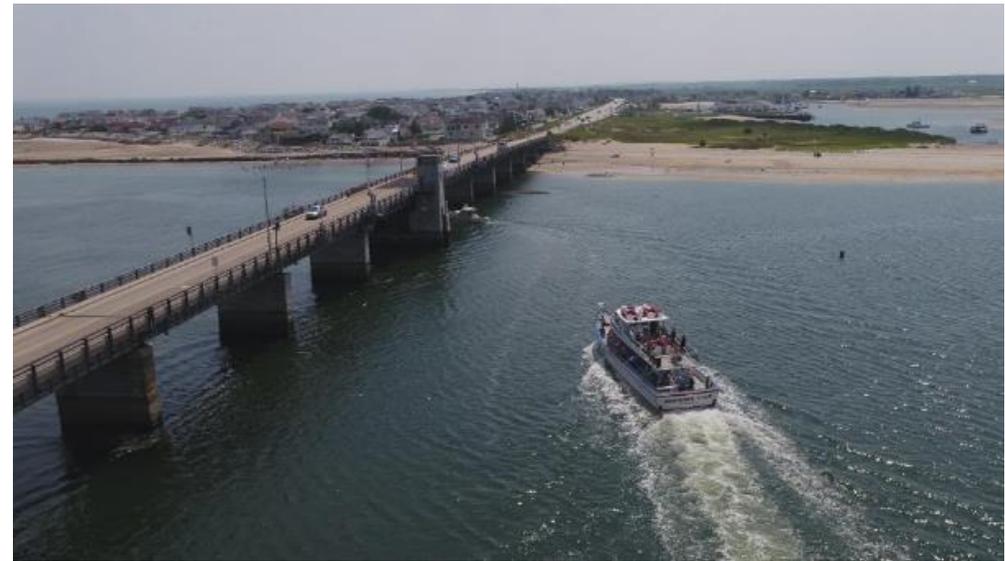
West Elevation

- NH Route 1A over Hampton Harbor
- Carries up to 18,000 vehicle per day during peak periods
- Recreational bicycle and pedestrian use
- Opens approximately 800 times per year for vessel movement in and out of Hampton Harbor

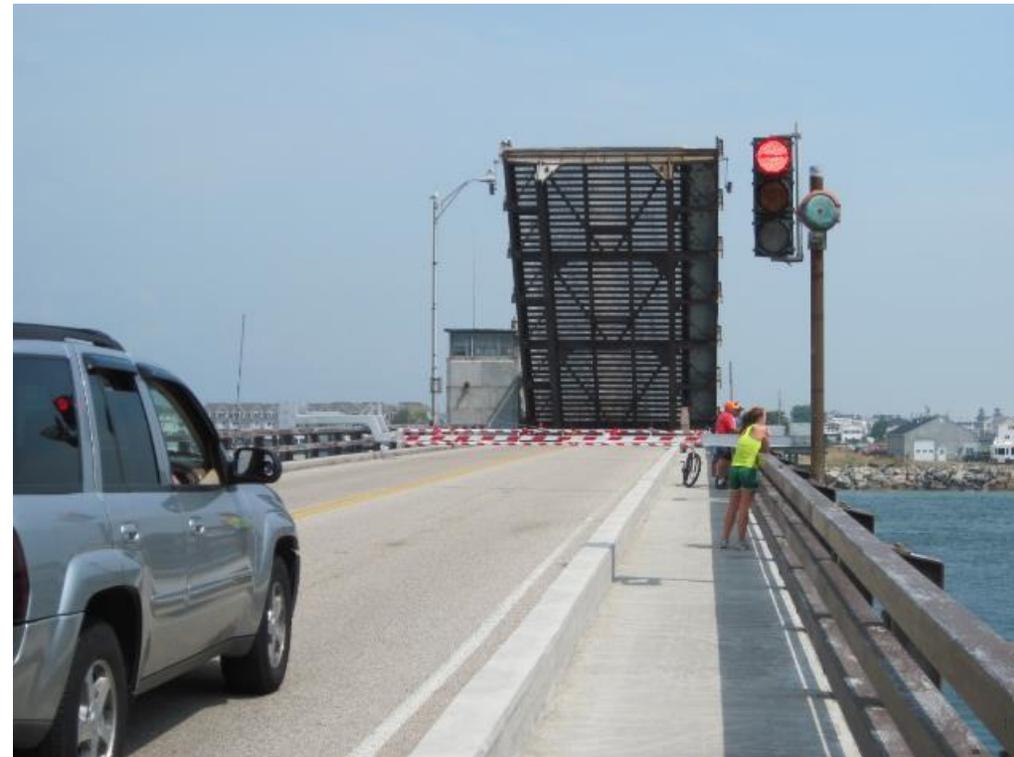
- Constructed in 1949
- One of two remaining bascule bridges in New Hampshire
- Overall Length: 1199'-0"
- Span Lengths: 12 fixed spans at 94 feet each and the 65-foot bascule span
- Overall Bridge Width: 33'-4"
- Roadway Width: 26'-0"  
(2 – 12'-0" Travel Lanes with 1'-0" shoulders)

Bascule span (open) looking North

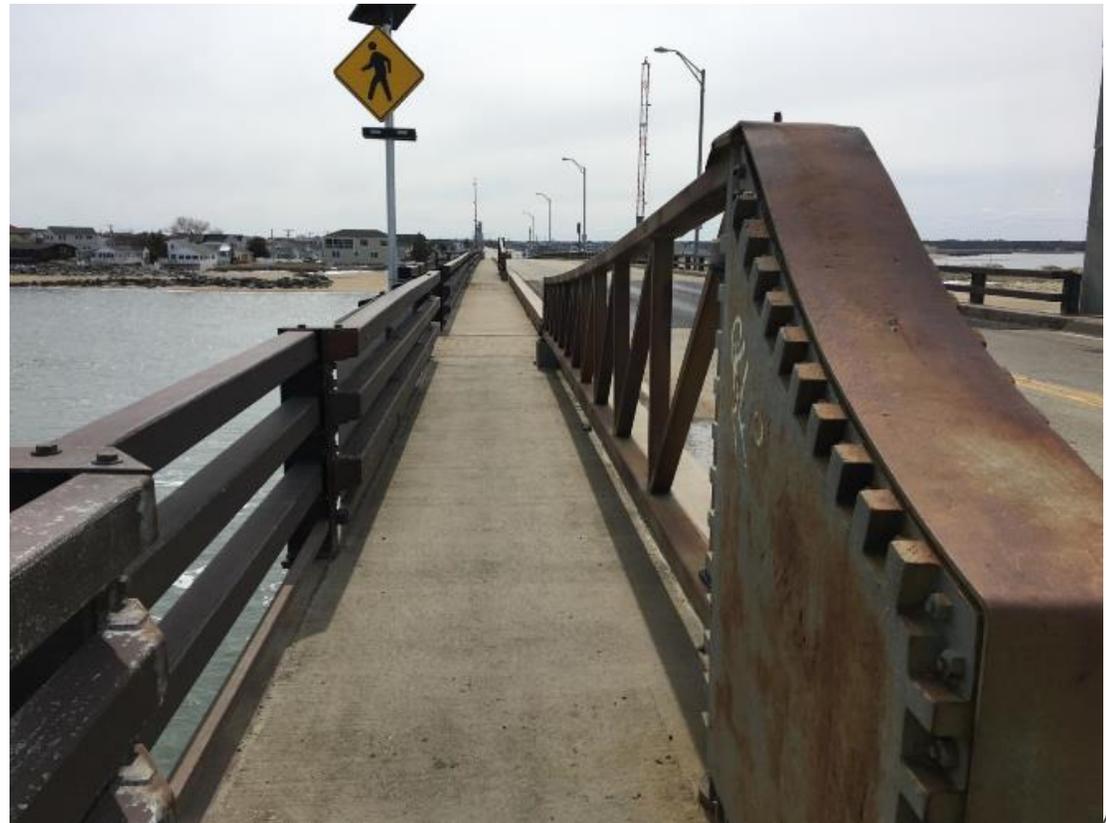
- No shoulders for bicyclists
- 5-foot minimum shoulder width recommended for safe passage of bicyclists
- 1 – 4'-7" Sidewalk on east side (narrows to under 4 feet at barrier gates)
- 5'-6" minimum sidewalk needed to meet ADA requirements

Existing sidewalk at barrier gate

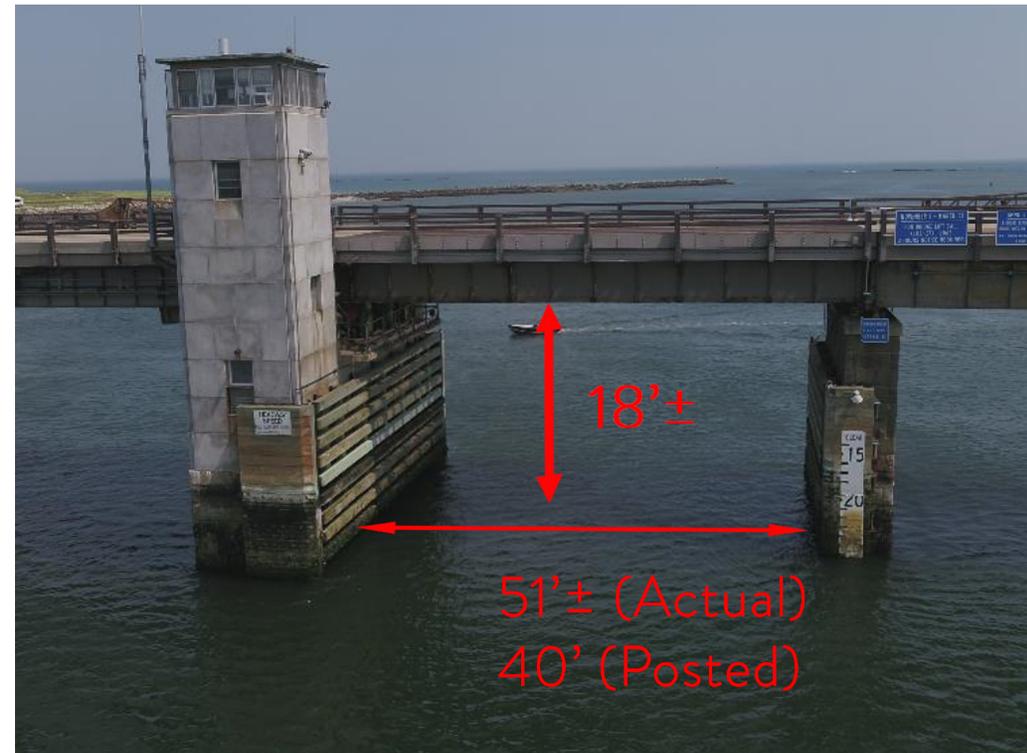
- Cannot clear of USACE owned dredge equipment
- Strong cross-currents make navigation challenging
- Width is significantly narrower than navigation channel.

Existing Navigational Clearances per Coast Surveys at Mean High Water

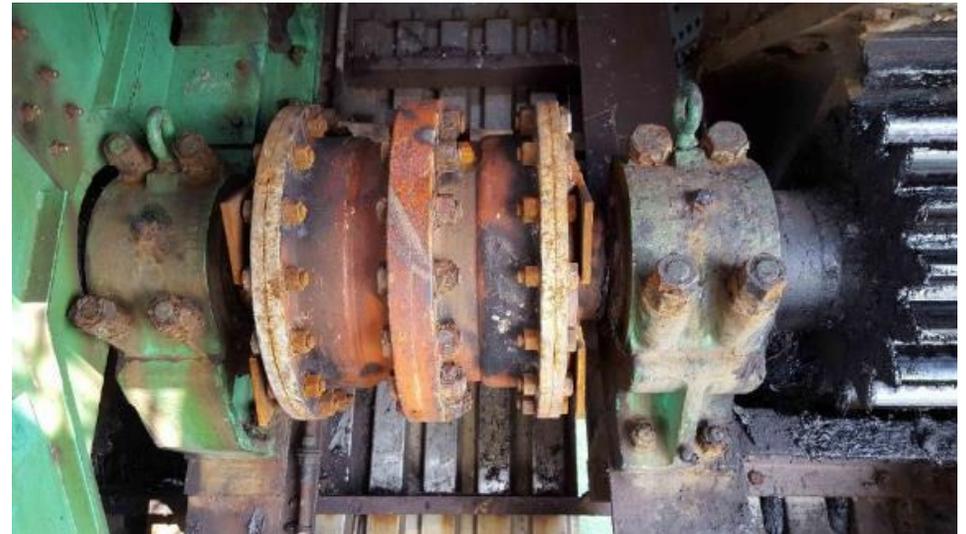
- Structurally deficient and functionally obsolete bridge
- Many original mechanical components and outdated electrical system
- Substandard shoulder and sidewalk widths

Deteriorated pinion and coupling, key elements of lift mechanism – Interim Repairs in 2018

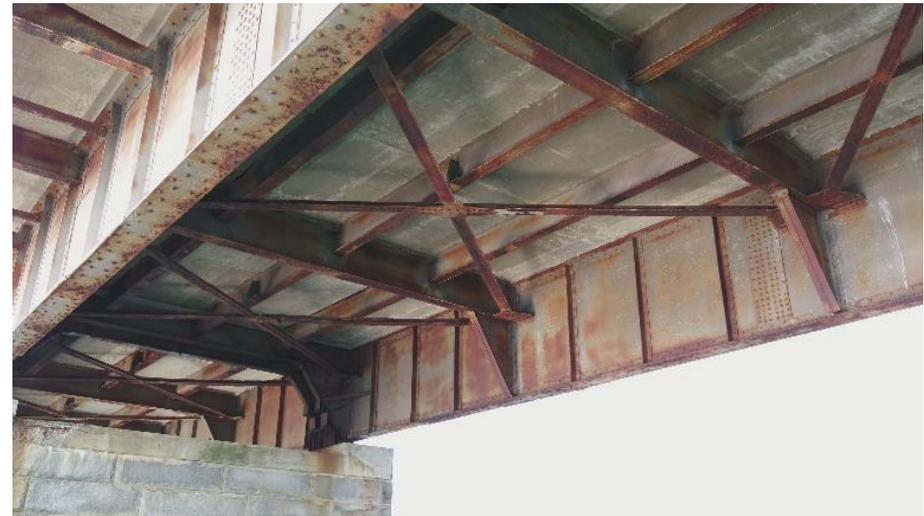
- Visual assessment and inspection of existing bridge
- Assessed rehabilitation for current capabilities, long term viability and for serving the purpose/need of project
- Requires significant modifications to carry current design loads, even without widening
- Insufficient capacity for widened roadway
- Geometry of bascule pier restricts ability to update mechanical systems

Typical Bridge Underside

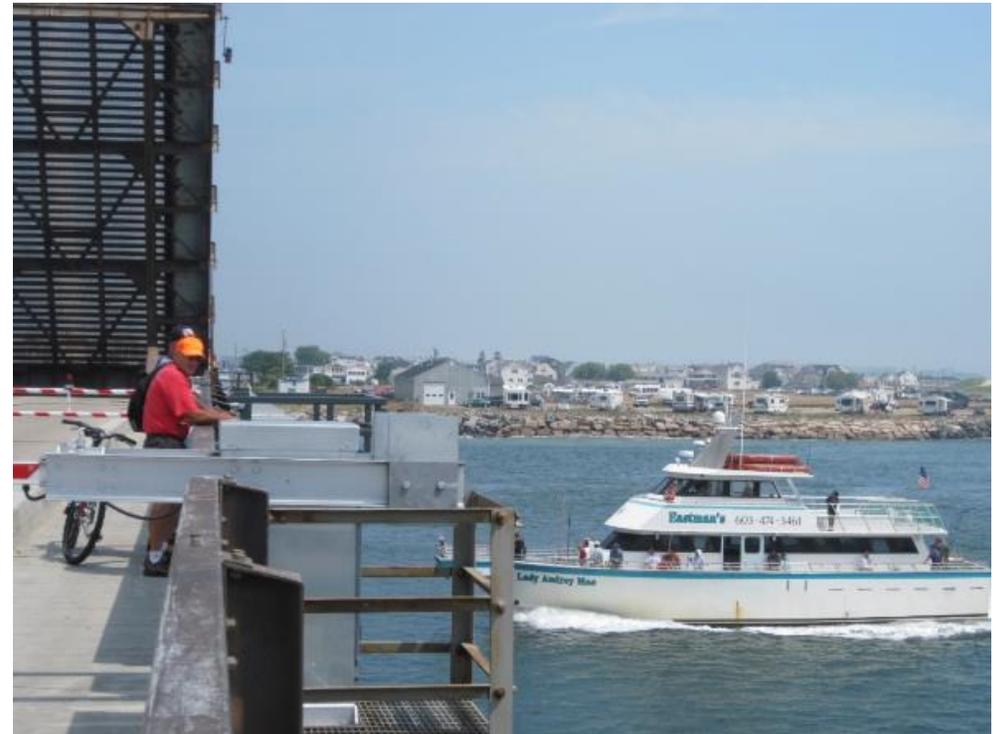
- Two Rehabilitation Alternatives under consideration
  - ▶ Replacement of full superstructure to widen bridge
  - ▶ Second movable bridge
- Bridge would need to be modified to carry modern design loads
- Providing widened roadway to meet needs of travelling public requires replacement of the entire superstructure (all steel girders) and widening of piers

Bridge open to allow for vessel passage

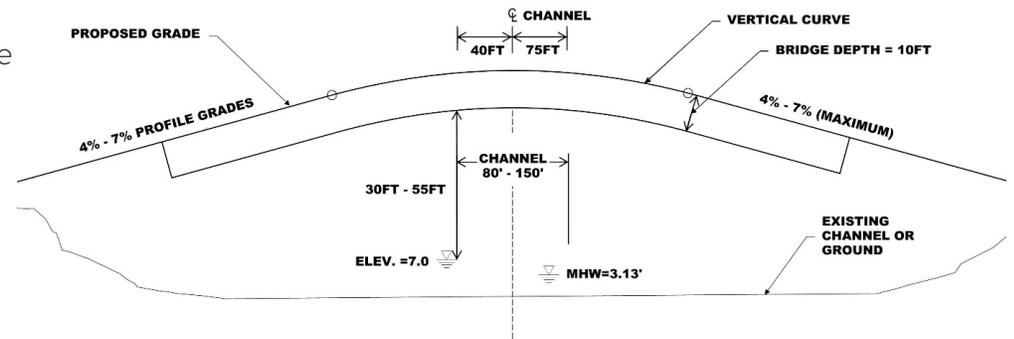
Roadway Slope	Serviceability for Ped and Bike
3%-4%	Desirable for Pedestrians and Bicyclists
5%-6%	Acceptable Per Code Requirements
7% or More	Less Desirable

- Roadway slope
  - ▶ Steeper slopes reduce approach impacts and improve navigation
  - ▶ Flatter slopes improve vehicular, bicyclist and pedestrian access
- Vessel Navigation Clearances
  - ▶ Higher clearances improve navigation and reduce impacts to roadway traffic
  - ▶ Lower clearances reduce approach impacts
  - ▶ Sea Level Rise
- East vs West vs Existing Alignment
  - ▶ Impacts of both alignments must be considered
- Impacts on Roadway Approaches
  - ▶ Informs impacts to resources, right-of-way and facilities on approaches
- Constructability and Cost
  - ▶ Full cost estimates not developed at this stage, but qualitatively considered

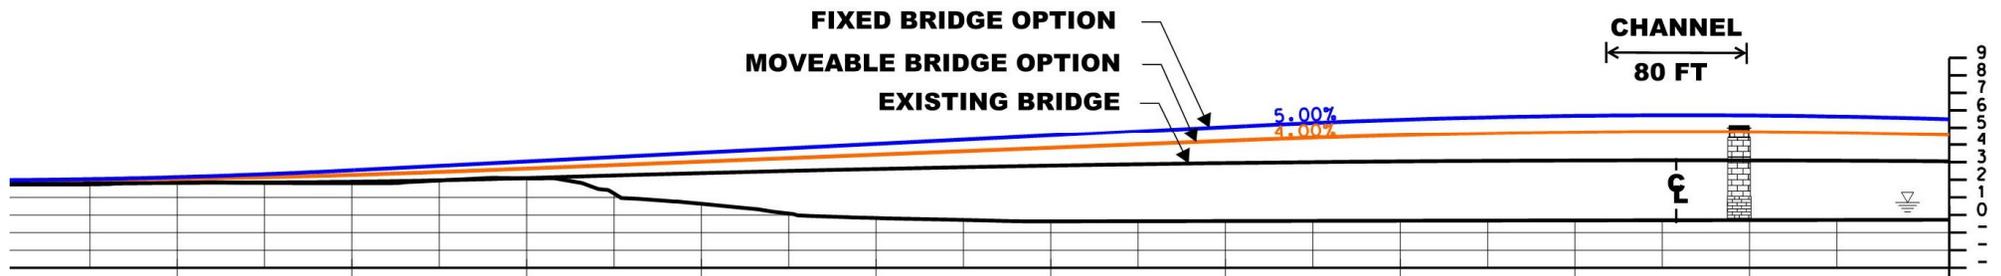
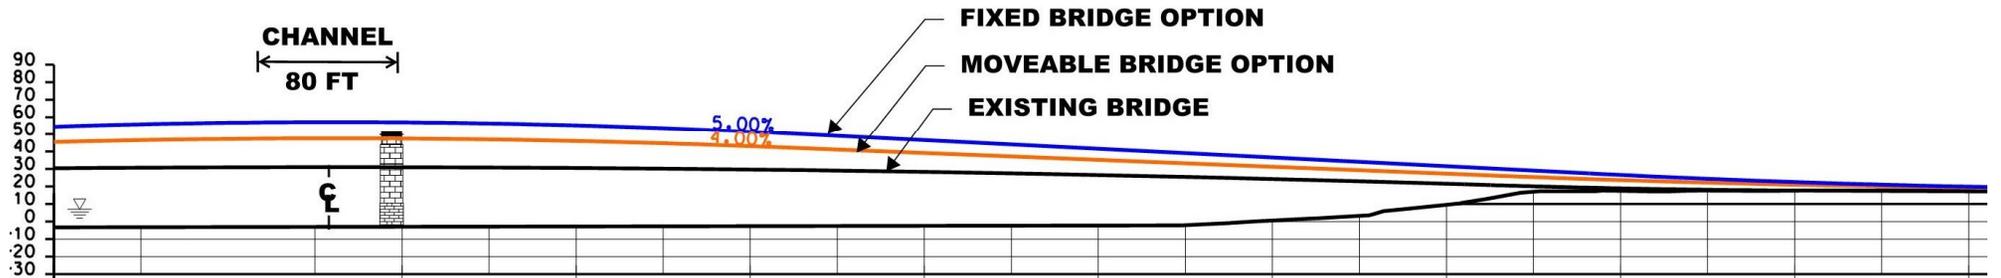
# Navigational Vertical Clearance

- Bascule Bridge
  - ▶ Proposed channel clearance: 80' Width, 34' Height with bridge in down position
- Fixed Bridge
  - ▶ Proposed channel clearance: 150' Width, 44' Height
  - ▶ 59' Height considered, not carried forward pending review by agencies
- Clearances include 3.9' Sea Level Rise
  - ▶ “Intermediate-High” range of estimated 2100 rise by NH Coastal Risk and Hazards Commission 2016 Report

Vertical Underclearance (from MHW)	Approx. Percentage of Lifts Eliminated
59'	Greater than 97%
44'	Greater than 90%
34'	Greater than 55%
18'	Current Clearance

- Provides improved underclearance for vessels
  - ▶ Clears USACE dredging equipment
  - ▶ Reduces lifts by over 50% based on current usage
  - ▶ Does not provide full 150' horizontal clearance
- Bridge will be required to lift and will still affect traffic
- Provides desirable roadway grade – 4% slope
- Smallest Impact on Approaches
  - ▶ Low height increase at abutment: 5' +/-
- Costs
  - ▶ Bascule Bridge - significantly higher capital costs compared to a fixed bridge
  - ▶ Higher risk of costs associated with serviceability – system breakdowns can impact vehicular and vessel traffic
  - ▶ Increased life cycle costs associated with operating the bridge and maintaining mechanical/electrical systems

- Provides improved underclearance for vessels
  - ▶ Clears at least 90% of current lifts
  - ▶ Clears all regular users
  - ▶ Provides significant improvement for horizontal clearance – 150'
  - ▶ Clears USACE dredge equipment at low tide
- No bridge lifts required with fixed structure – no impact to roadway traffic
- Provides acceptable roadway grade – 5% slope
- Balances impacts on approaches
  - ▶ Height increase at abutment: 10'±
- Fixed Bridge - significantly reduced capital and life cycle costs compared to a bascule bridge
- Bridge can be designed to carry utilities across the harbor

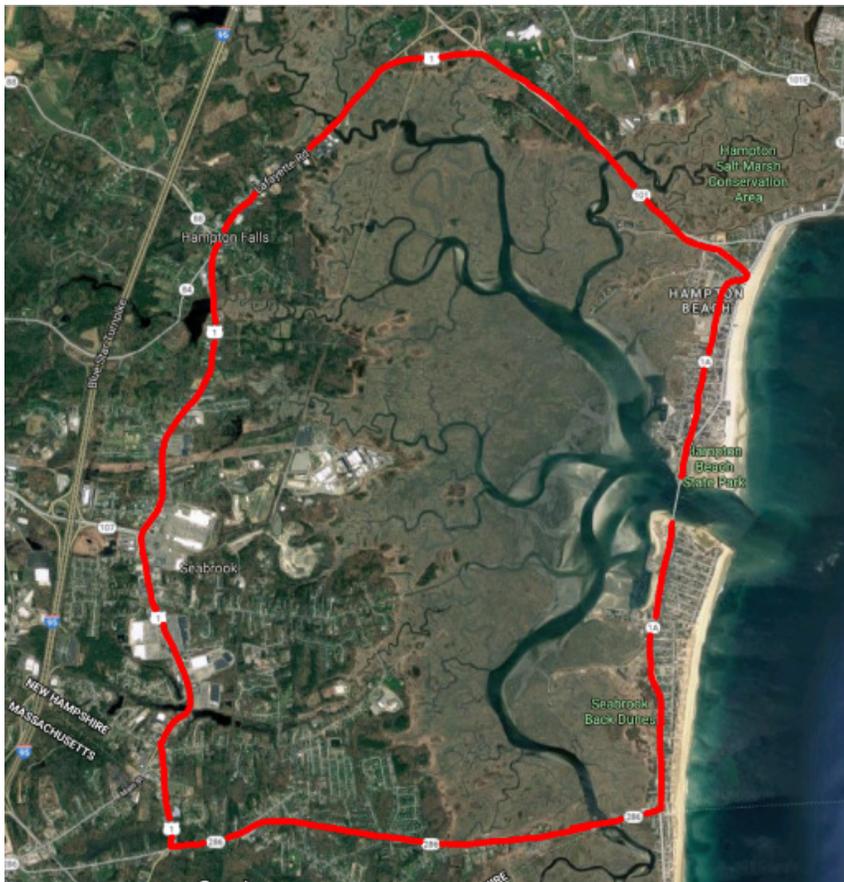
Detour Map

- ▶ Full Closure w/ Regional Detour
  - Construction Schedule 2+ years depending on Environmental Restrictions
  - Required detour is approx. 12 miles
- ▶ Temporary Bridge Required
  - Increases Cost Significantly – on the order of \$20 million or more based similar project
  - Lengthens Construction Duration by 1 year or more for construction of temporary moveable bridge

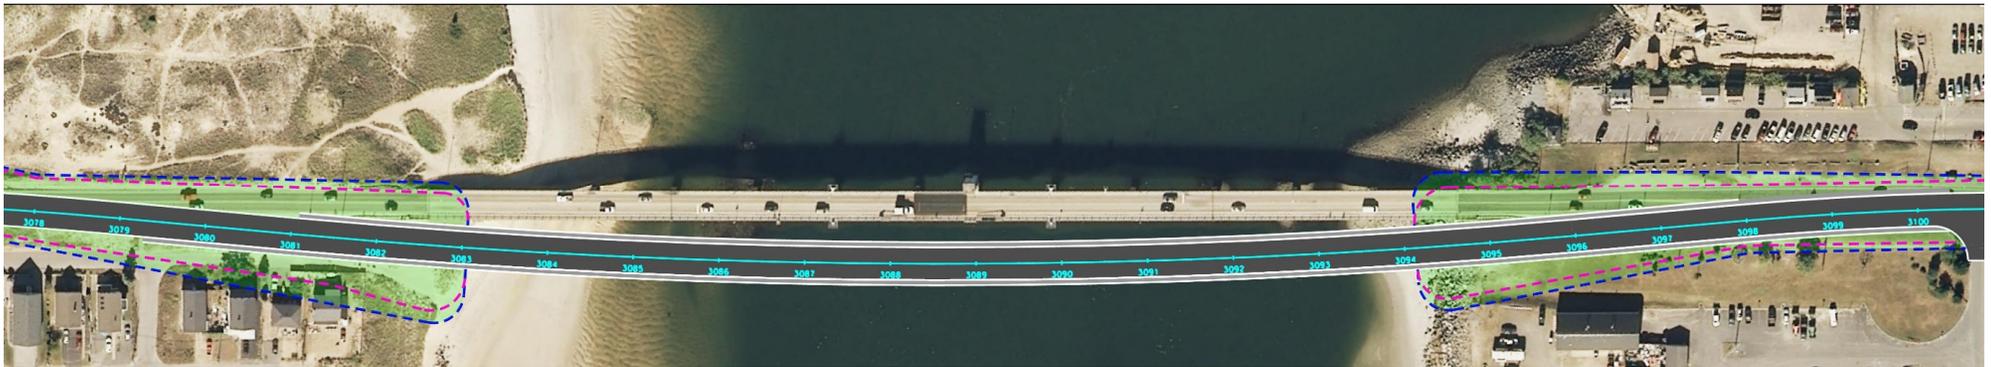
# Eastern Alignment

West Alignment	East Alignment
Underwater and Underground Utilities	Underground Utilities
Hampton and Seabrook Channel	Entrance Channel
Beach usage at South Abutment	Beach usage at South Abutment
Sensitive Habitat / Conservation Area	Sensitive Habitat
Potential Impact to Businesses And Driveway	Impacts to State Park Entrance
	Impacts to homes on SE quadrant

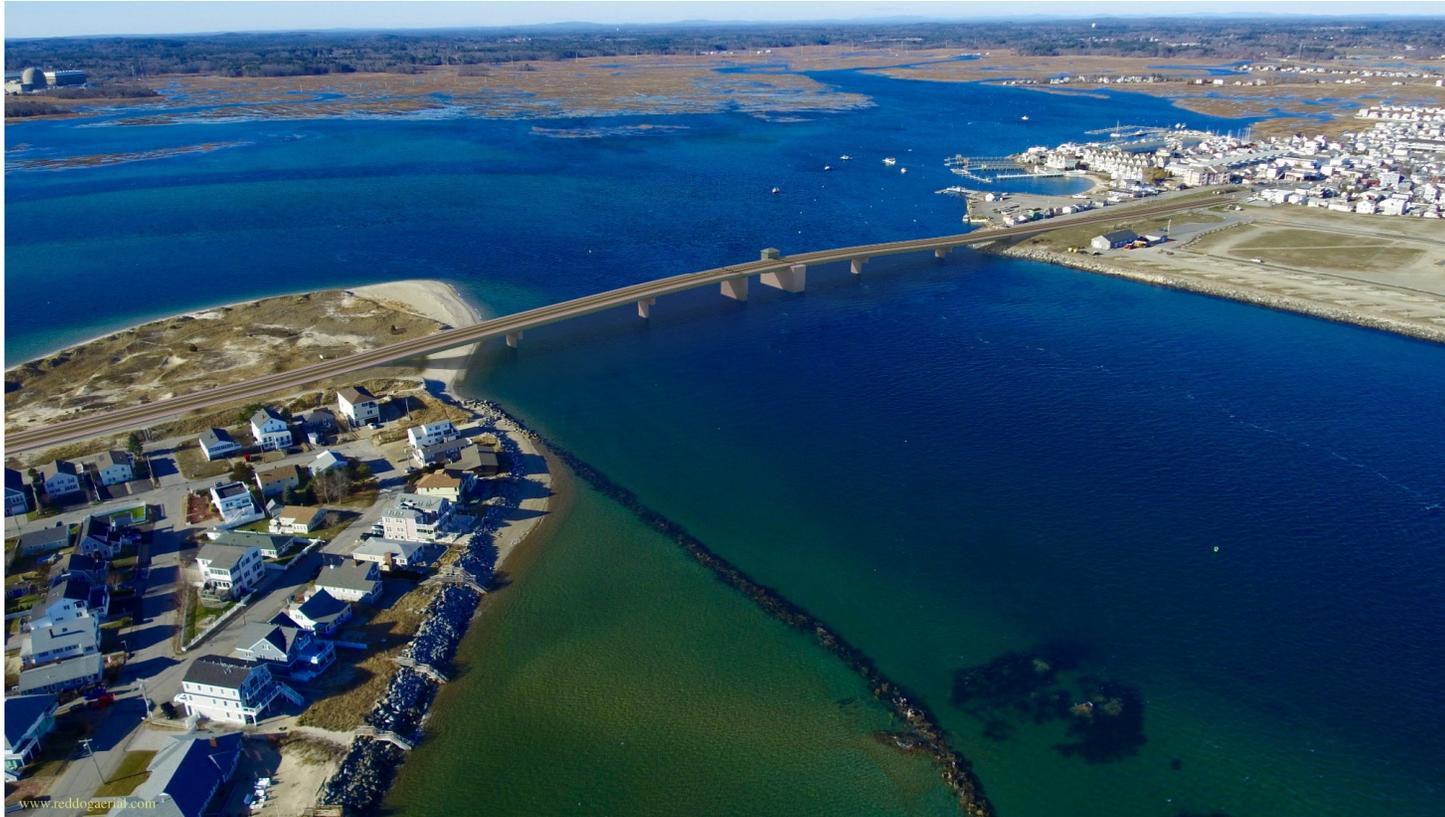
Aerial of Proposed Bascule Bridge

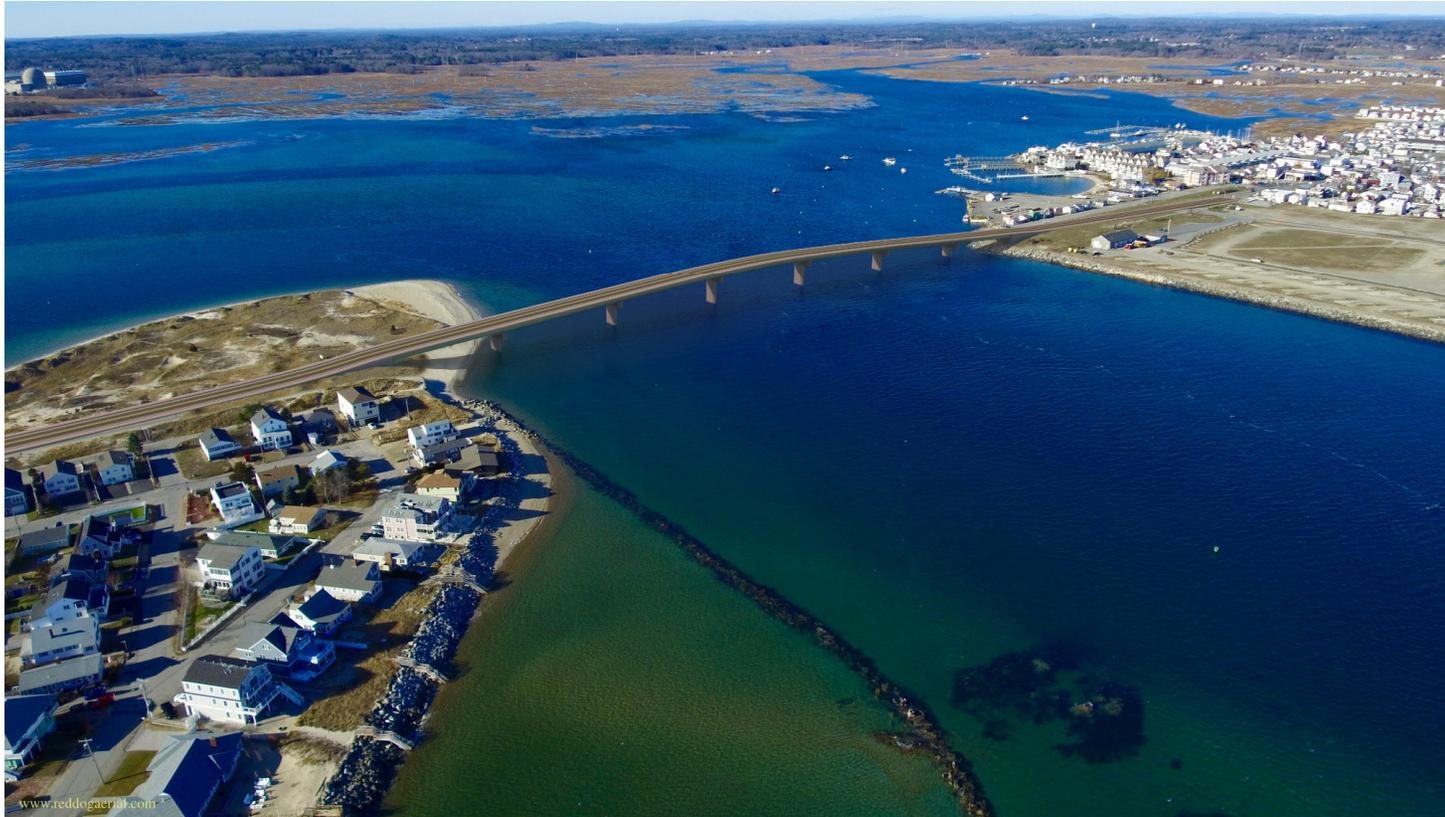
Aerial of Proposed Fixed Bridge
